Subject: Recall Campaign JA (04V-007)

2004 Model Year Audi TT 3.2L Direct Shift Automatic Transmission Vehicles

Replace Dual Clutch

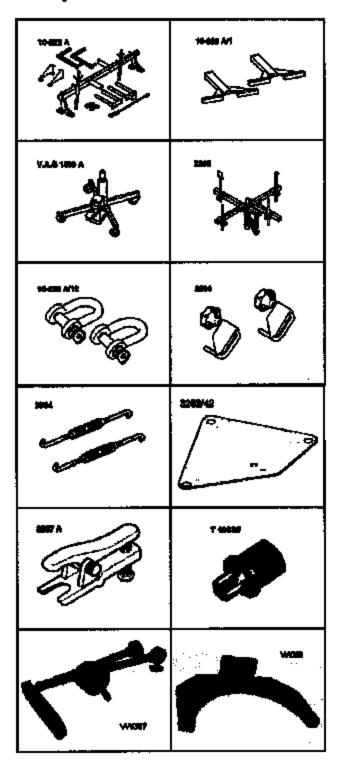
Special Tools:

- Support bracket 10-222 A
- Bracket 10-222 A/1
- ⇐ Engine/transmission jack V.A.G. 1383 A
- ← Transmission support 3282
- ← Shackle 10-222 A/12
- ← Hose clamps, up to 25 mm diameter 3094
- ← Hooks 3004
- ← Adjustment plate 3282/42
- Universal attachment for jack V.A.G. 1359/2 (or equivalent)
- ← Ball joint puller 3287 A
- ← Multi-point tool T 10035
- Tensioning strap T 10038 or equivalent
- ← VW387 Dial gauge holder
- ← VW353 Transmission support
- VW313 Support clamp
- VW309 Support plate
- Dial indicator
- Electronic wheel alignment machine
 V.A.G. 1813 or equivalent

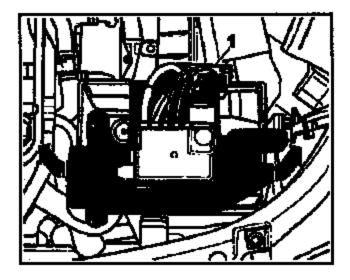
- Loosen clamp -2- and remove air hose from the throttle body housing
- Disconnect the electrical connector -3from the Mass Airflow Sensor (MAF)
- ← Remove bolts -1- and -4-
- ← Move wiring harness -arrow- aside
- Remove the air cleaner housing with MAF and air hose

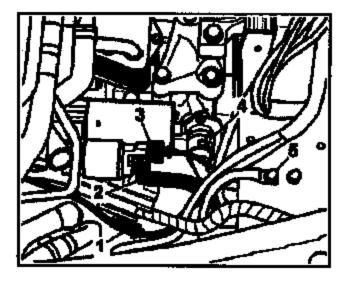
- □ Disconnect electrical connectors -3- and -4-
- Remove the mit at the starter solenoid terminal B+ -2- and remove the connector cyclet from the terminal
- Unclip guide from wires
- · Remove wire guide

CAUTION: DO NOT LOOSEN OR REMOVE GROUND (GND) CONNECTION -5-

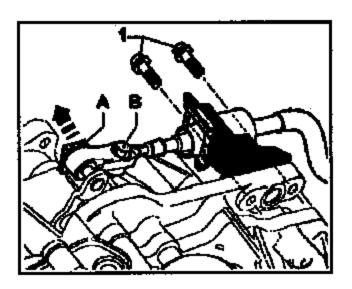
- Slide circlip -A- upward and remove it in direction of arrow
- Remove selector lever cable off selector shaft lever in direction of arrow and place on top
- ⇐ Remove torx bolts -1-

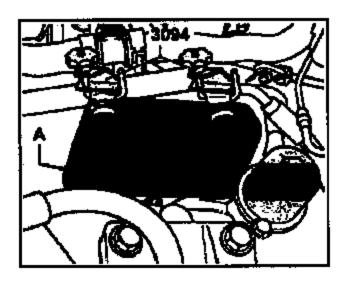
- Clamp off transmission oil cooler hoses using hose clamps -3094- and disconnect at transmission oil cooler -A-
- Seal off transmission oil cooler with clean plugs

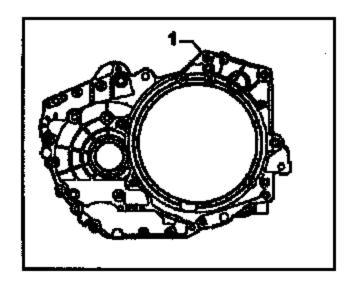
← Remove engine/transmission connecting bolt
 -1-

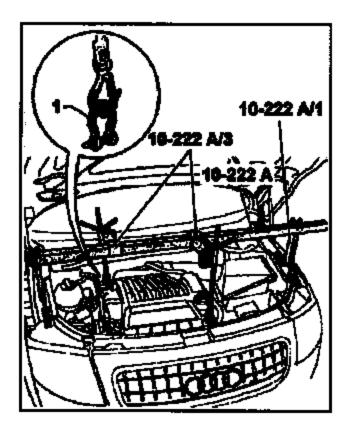
- Assemble support bracket 10-222 A together with brackets 10-222 A/1 and 10-222 A/3
- Position support bracket on wheel housing flange
- ☐ If there are hoses and cable connections in area of engine lifting eye for support bracket 10-222 A, move them aside
- On right side, attach hook of spindle to engine lifting eye with a shackle 10-222 A/12 -1-
- Take up the weight of engine/transmission assembly via spindles on the support bracket
- Raise vehicle on hoist

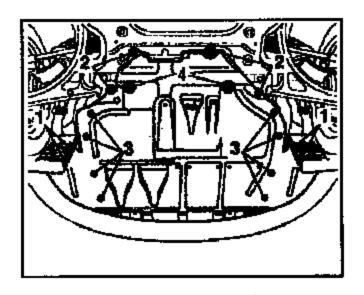
- ← Unclip clips -1-

- Remove center sound insulation panel and set aside

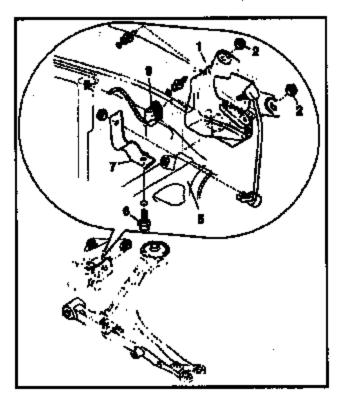
- Remove front wheels
- If the vehicle is equipped with automatic headlight control, disconnect connecter -9from the sensor -1-
- Remove bolt -6- and disconnect linkage arm bracket -7- from the lower control arm -5-
- Remove nuts -2- and remove sensor with mounting bracket

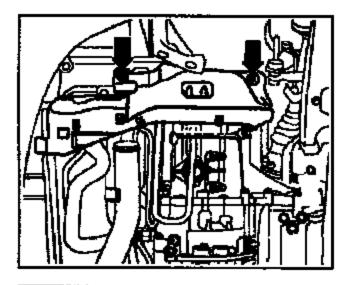
Remove fasteners -arrows- and left side sound insulation panel

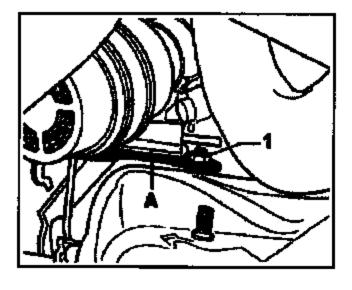
- Remove nut -1- and other nut securing the secondary air pump air filter holding bracket -A-
- Disconnect air hose from the air filter and remove air filter

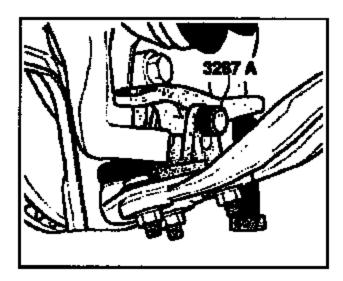
- Use ball joint puller 3287 A and press out ball joints on the right and left control arms
- Remove ball joint puller

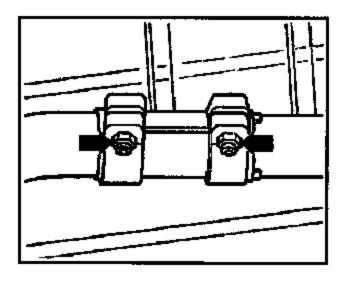
- Loosen nuts -arrows- and disconnect exhaust system at clamp
- Slide clamp rearward onto exhaust pipe

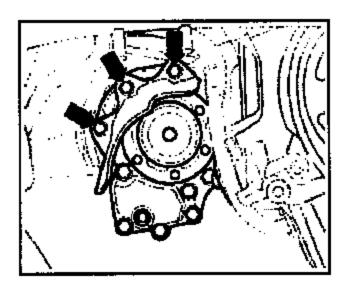
- Remove allen head nuts -arrows- and remove the axle shaft heat shield from the bevel box
- Remove bolts securing right axle to flange on the bevel box
- Remove bolts securing left axle to flange on the transmission
- Lift axis shaft (right side) up and secure with wire

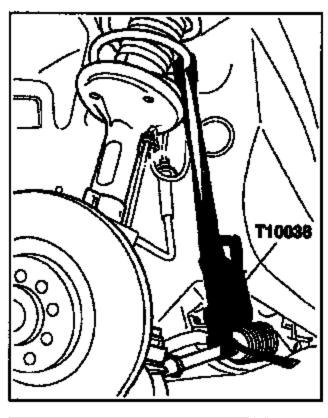
Secure the tie rods to the suspension strut just in front of the inner rubber boot using tensioning strap T 10038, to prevent the steering column from sliding off the splines of the steering gear

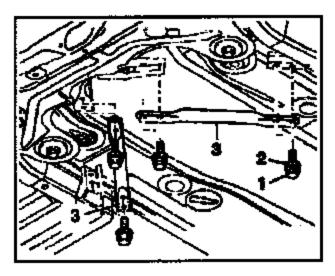
Remove eight bolts -1- with locking washer -2and remove reinforcement -3-

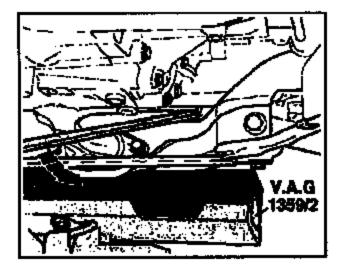
Carefully pry off the sub-frame for steering gear using a pry bar

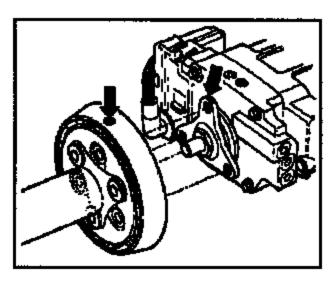
Mark position -arrows- of drive shaft with flexible coupling in relation to bevel box flange

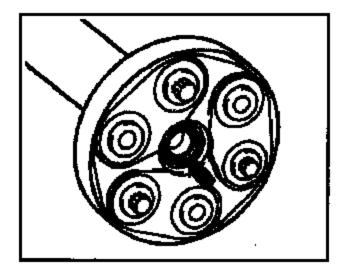
Move drive shaft horizontally to rear as far as possible

CAUTION: WHEN REMOVING THE TRANSMISSION, MAKE SURE THE SEAL -ARROW- IN THE DRIVE SHAFT FLANGE IS NOT DAMAGED. IF THE SEAL IS DAMAGED, THE DRIVE SHAFT MUST BE REPLACED.

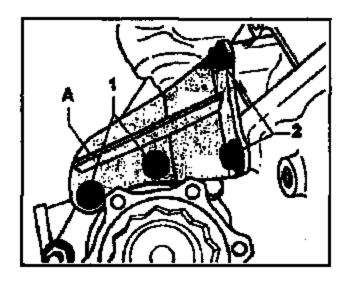
- Remove bolts -1- and -2- and remove bracket for bevel box
- · Lower vehicle on hoist

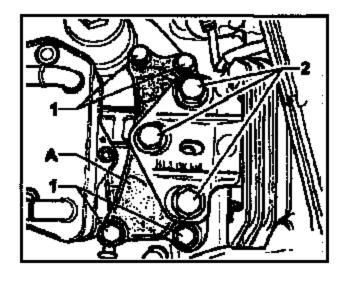
- From above in the engine compartment remove starter in an upward direction
- ← Remove transmission mounting bracket -A-

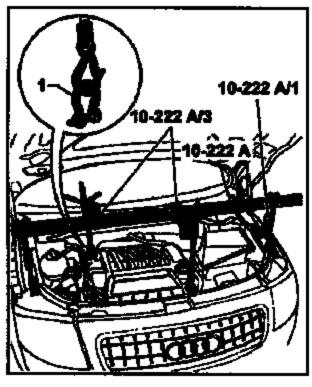
Carefully lower engine/transmission assembly using spindles 100 to 110 mm (3.9 to 4.3 inches) see <u>next</u> illustration for location of measurement

- Cistance -a- = 100 to 110 mm (3.9 to 4.3 inches) measured between transmission housing and mounting
- To remove the direct shift transmission 02E the transmission support 3282 is set up together with the adjustment plate 3282/42
- Align arms of transmission support according to holes in adjustment plate
- Bolt support elements as illustrated to adjustment plate 3282/42
- Place transmission jack under vehicle at arrow symbol on adjustment plate points in direction of travel/to front of vehicle
- Align adjustment plate parallel with transmission

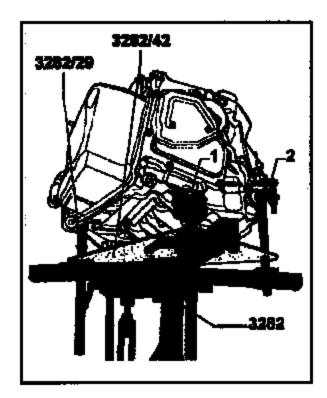
- Secure support element to transmission using bolt -1-
- Screw support element 3282/29 into transmission.
- Insert support element -2- into transmission;
 secure by tightening nut

- Support transmission by lifting transmission jack from below
- Remove bolts -5-, -6-, -7-, -8-, -9- and -10securing transmission to the engine

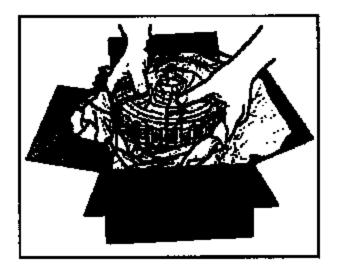
- Take the retaining ring out of the packaging
- ← Obtain new dual clutch (02E 141 029E) from repair kit; remove packaging while pressing the drive plate into the outer plate carrier with both thumbs

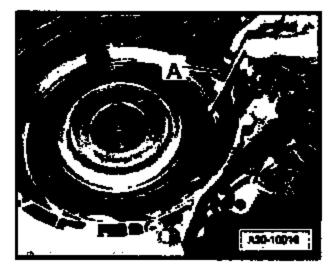
CAUTION: DURING THE
FOLLOWING STEPS,
YOU MUST KEEP
PRESSING THE DRIVE
PLATE INTO THE
OUTER PLATE
CARRIER WITH BOTH
THUMBS TO ENSURE
THAT IT REMAINS IN
POSITION BETWEEN
THE SPLINES OF THE
OUTER PLATE
CARRIER.

- Check that the four oil seals -B- on the hub on the under side of the dual clutch are correctly seated; engage in position, if necessary
- While turning the new dual clutch in both directions, as well as moving it slightly up and down, lower it slightly onto the input shaft and at the same time insert the assembly tool -A- between the dual clutch and the bell bousing. Turn it to a position at the edge of the housing so that it holds the dual clutch at a defined height.

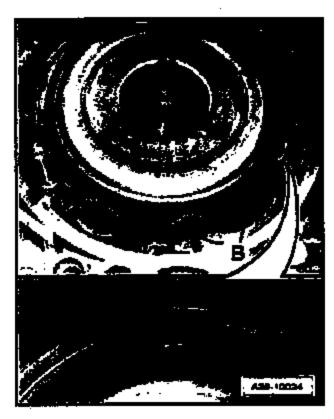
The drive plate -A- is fitted in a specific position in relation to the outer plate carrier -B-

CAUTION: THE CORRECT POSITION
FOR THE DRIVE PLATE
TO BE INSTALLED IS
WITH THE PROJECTING
LUG ALIGNED BETWEEN
THE COLOR-MARKED
SPLINESON THE OUTER
PLATE CARRIER.

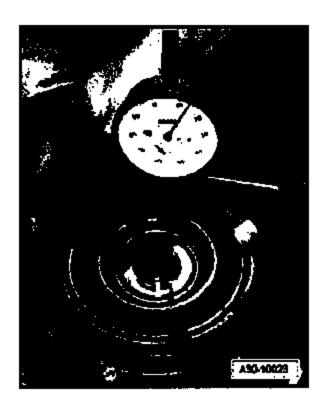
Lift clutch assembly as far as it will go and read total play "S₁" indicated on the dial indicator gauge

Use the formula → "T_{circlip new"} =
 "S₁" - "B_{W1}" + 1.85 mm and calculate
 the thickness of the new circlip

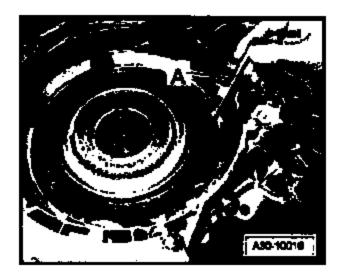
Requirements:

- The projecting ing on the drive plate must be positioned between the color marked splines on the outer plate carrier
- The circlip must be installed so that the lug on the drive plate and the color-marked splines on the outer plate carrier are located between the two ends of the circlip

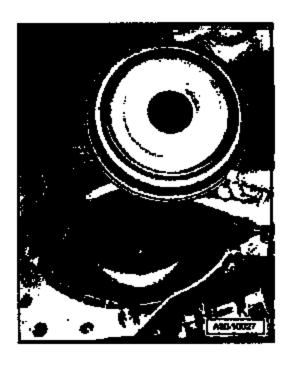
Clean the bell housing surface where the outer seal of the end cover will contact it

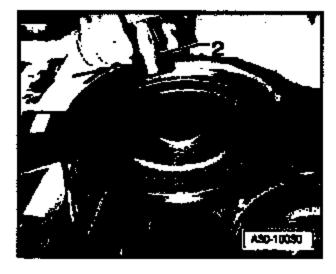
Using the assembly tool from the repair kit, fit the clutch end cover on the tool

The end cover must be in full contact with the assembly tool

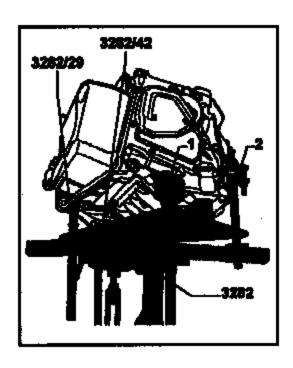
- Lubricate the splines -arrow- for the dualmass flywheel with a small quantity of assembly grease (G 000 100)
- Rotate the transmission support clamp, VW 313, to the normal position, e.g. with the breather openings facing upwards
- Carefully remove the transmission from the VW353 holding plate and place on the 3282 transmission support
- Proceed to Section C

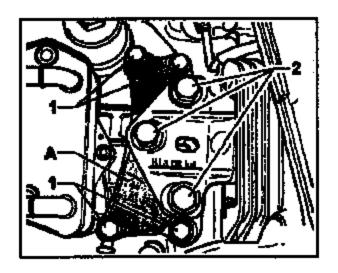
- Reinstall bracket -A- on bevel box
 with bolts -1- and -2- and hand tighten
- ← Tighten bolts -1- and -2- in the following sequence:
 - Bolt -1- initially to 3 Nm (2 ft, lbs.
 - Bolt -2- to 35 Nm (26 ft. lbs.)
 - Bolt -1- to 45 Nm (33 ft, lbs.)

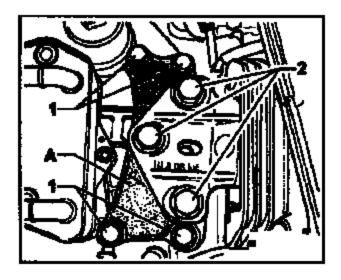
- Lower vehicle and place transmission support -A- between transmission and transmission mounting
- Using new bolts -1- (N 905 970 02) secure transmission support (hand tighten only)
- Pull transmission up to transmission mounting using spindle on support bracket
- Using new bolts -2- (N 102 096 03) secure transmission support to transmission mounting (hand tighten only)
- ← Tighten bolts -1- to 50 Nm (37 ft. lbs) plus turn an additional 90°

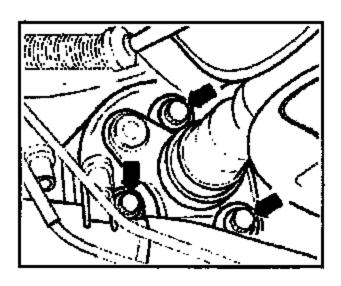
IMPORTANT! Ensure the drive shaft is horizontal when pushing it onto the guide pin

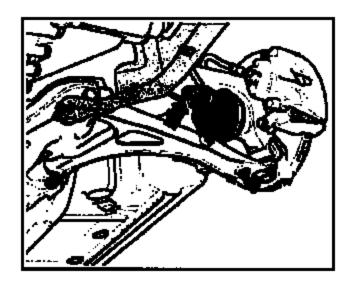
Reinstall reinforcements -3- and secure with bolts -1- and tighten to 35 Nm (26 ft. lbs.)

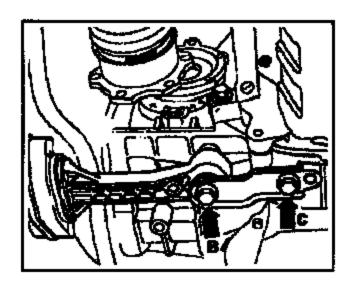
- Secure right and left couplings to the stabilizer bar using new nut-arrow-(N 015 081 4) and tighten to 90 Nm (66 ft. lbs.)
- Remove strap tool T10038 holding tie rods and steering gear box

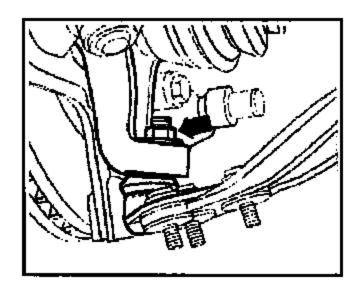
- Reposition clamp to connect exhaust pipes and tighten nuts on clamps to 40 Nm (30 ft. lbs.)
- ← Remove hook tool 3004

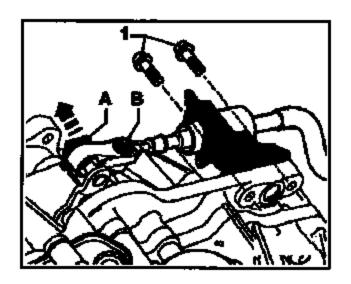
- Remove engine/transmission support bracket 10-222 A
- Reinstall top center engine/ transmission securing M12x55 bolt -1- and tighten to 80 Nm (59 ft. lbs.)
- Reconnect hoses to transmission oil cooler and remove 3094 clamps

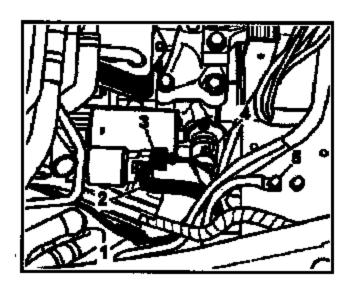
- Using new Torx bolts (N 909 861 01) secure selector cable bracket to the transmission and tighten bolts to 20 Nm (15 ft. lbs.) plus turn an additional 90°
- Carefully press selector lever cable onto selector shaft lever on transmission in opposite direction of arrow
- Install circlip -A- and press downward to secure
